## Technical Service Bulletin # 1

**Product:** Incubator 8000 SC

**Date:** November 30, 1999

**Re:** Incubator 8000 SC, increase of operational security of the fan

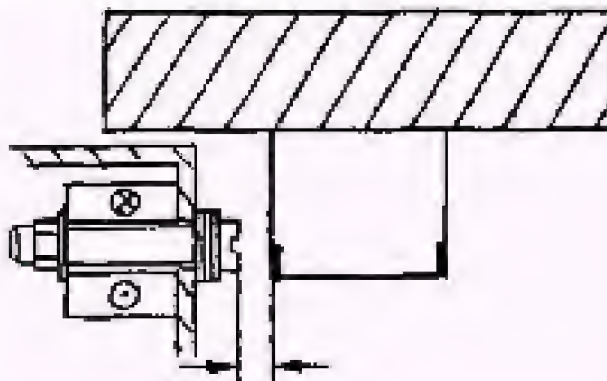
**Reason:** Fan failure alarm has occurred sporadically in some Incubator 8000 SC devices.

**Solution:** In order to improve the fan monitoring in the Incubator 8000 SC, a field change must be implemented as a precautionary measure. A screw (M3) is used both as coil core and mount. Three washers must be used to achieve the proper distance between the screw head and fan wheel.
